Lake Grace Available Sources

Update for Farmers

16/04/2019 follow site survey conducted during week of the 18th of April
2019

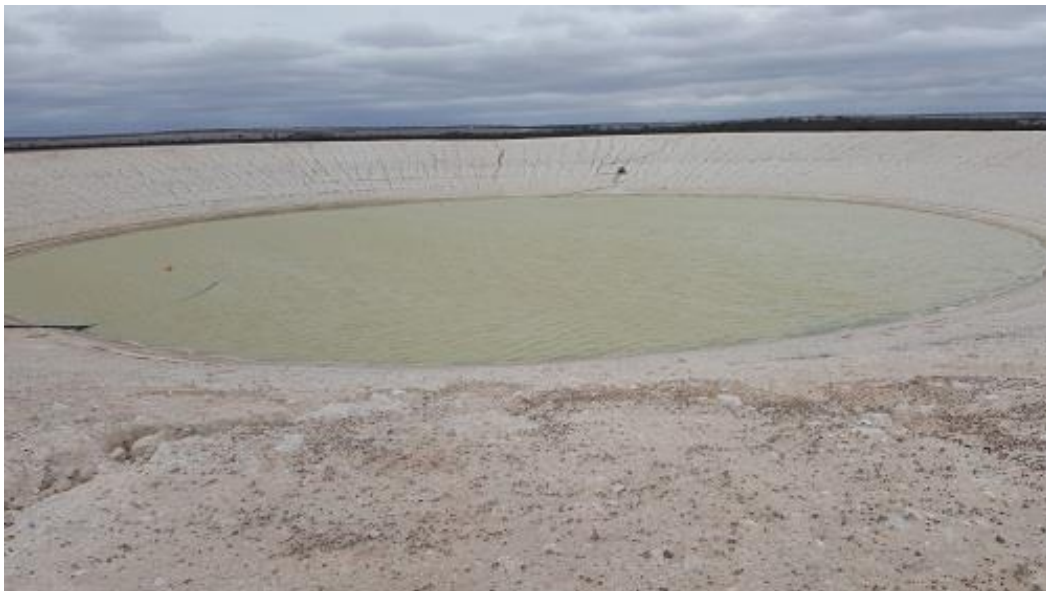
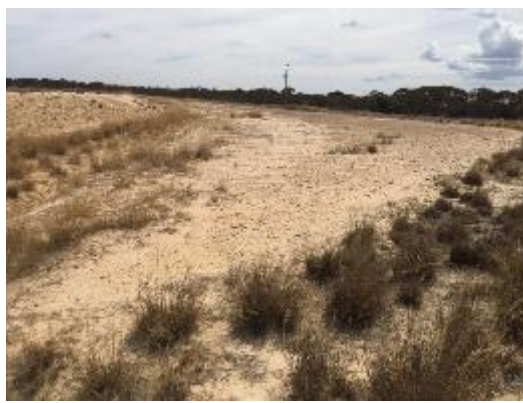
Dunn Rock

Location – South Newdegate

2 dams – Taylor road opposite CBH facilities

Dam with Standpipe low levels but dam west of CBH 25% of capacity
~10,250KL available.

Pump repairs – electrics being checked and access to 2nd dam below complete..
While facilities are operating supply is diminishing (2nd below).

Option to access Magenta Dam, Pallerup Standpipe, Mt Madden Bore/Dam

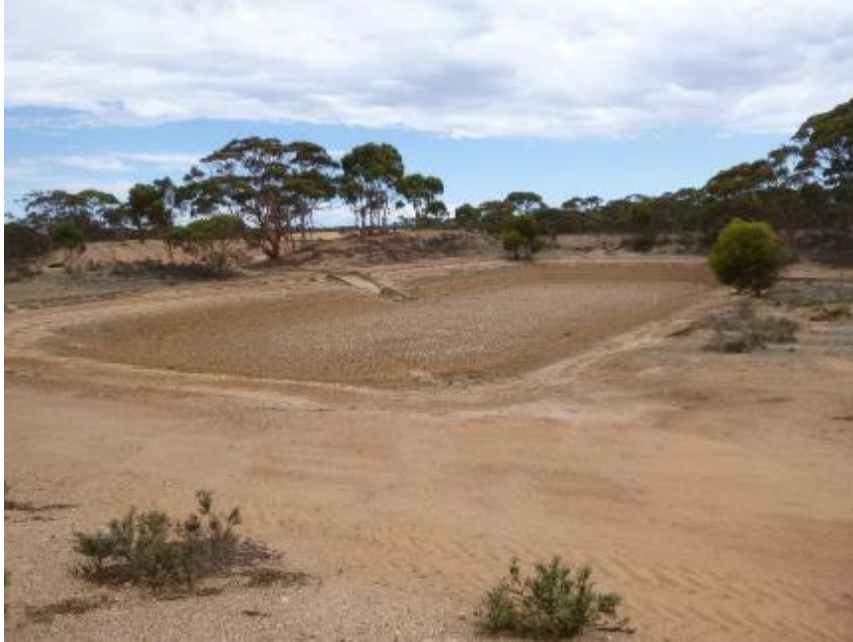
South East Newdegate (Cuffy's)

Location- Pingrup Road

2 dams

Current capacity: dry

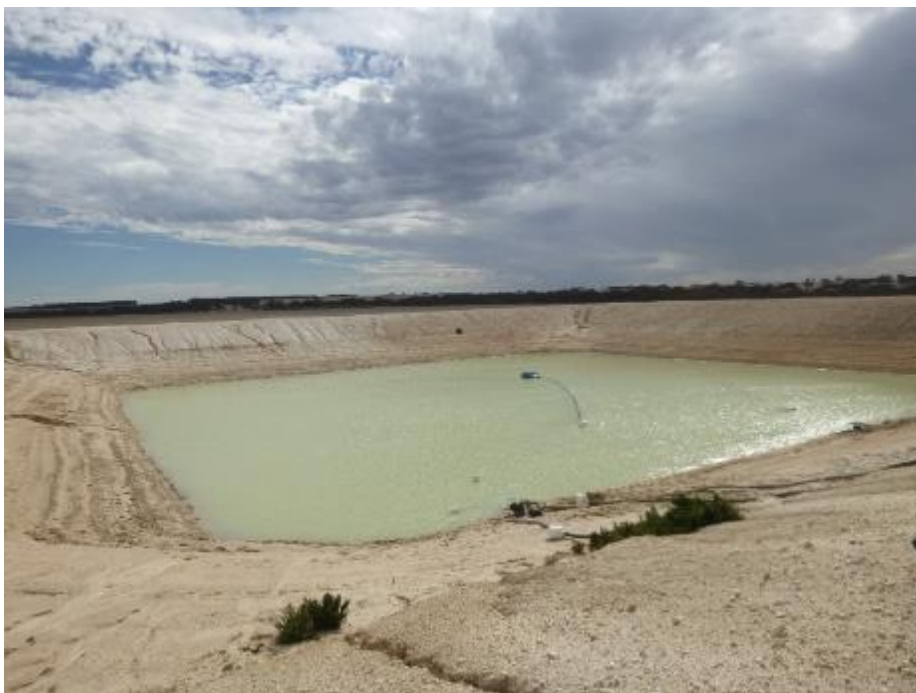
Magenta North

Location - Ardler Road

2 dams (one silt trap dam)

~15,000 KL capacity

Current capacity <25% capacity =~3000 KL available

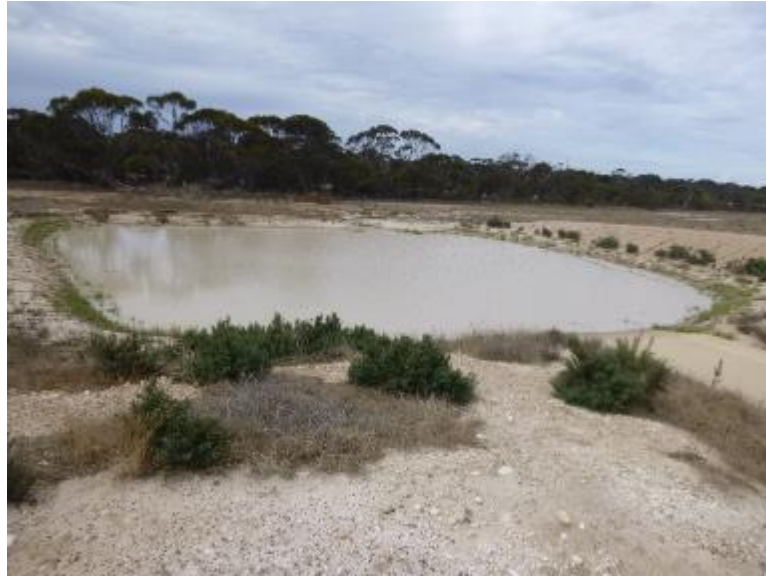
South East Newdegate

Location – Magenta Road

2 dams (one silt trap dam)

15,000 KL capacity

Current capacity <10% 1500 KL available

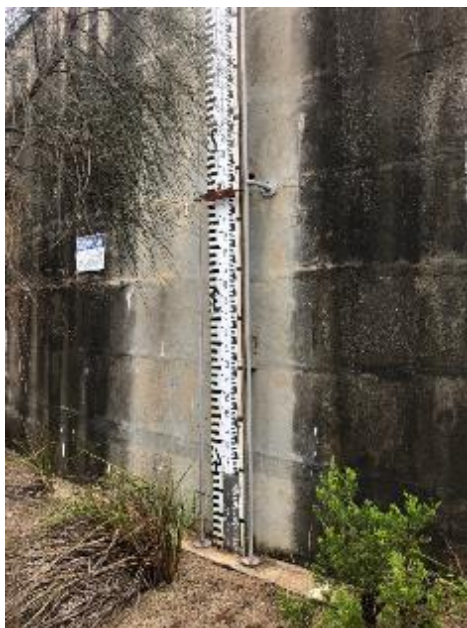
East Newdegate (Machetti' s Tank)

Location – Haigh Road East Newdegate Swipe card controller in place.

Tank off rock catchment

4550 KL capacity

Current capacity ~45% 2134KL available

16/04/2019 analysis of swipe card use since site visit ~ still at 45% (2134 KL)

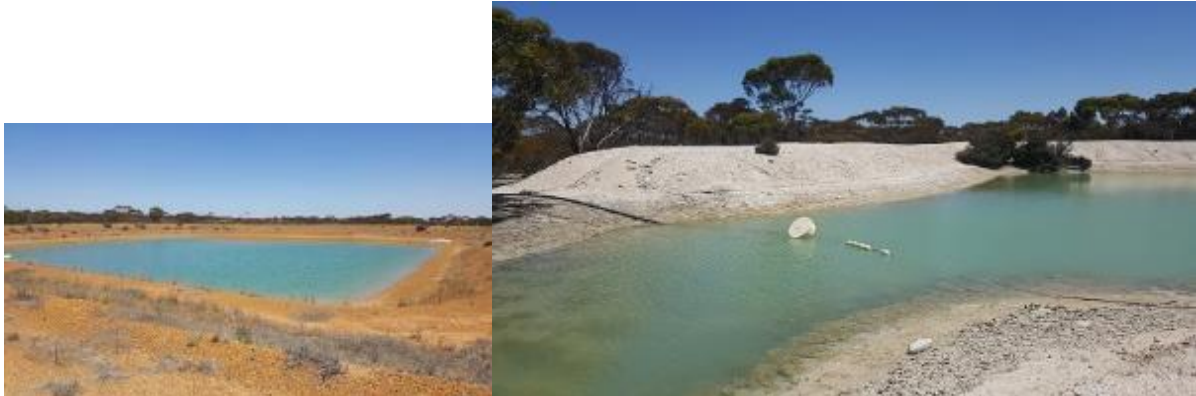
Lake King tank and standpipe

Tank Location – Lake King near museum Swipe card system in place.

Source – old drinking supply dam

Pump in place and tank full. Pressure switch to be installed. Water in main dam is near full and will be used to top up Community Dam.

Status –available.

Maximum Capacity with adjacent old drinking water supply dam 20,000KL

100% available

Old drinking dam will top up Community dam above

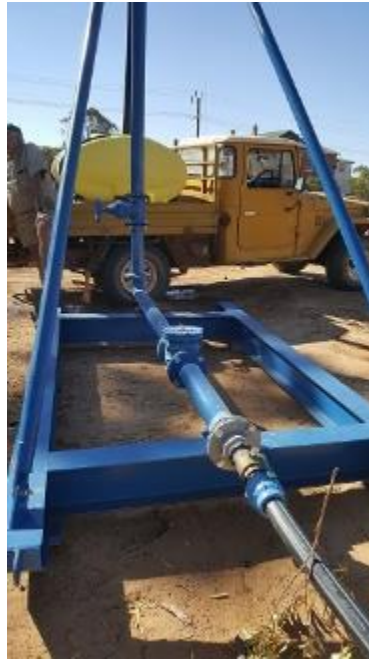
Newdegate town dam

Location – Newdegate

Water Corporation made available a temporary emergency farm water supply. Located in the town site.

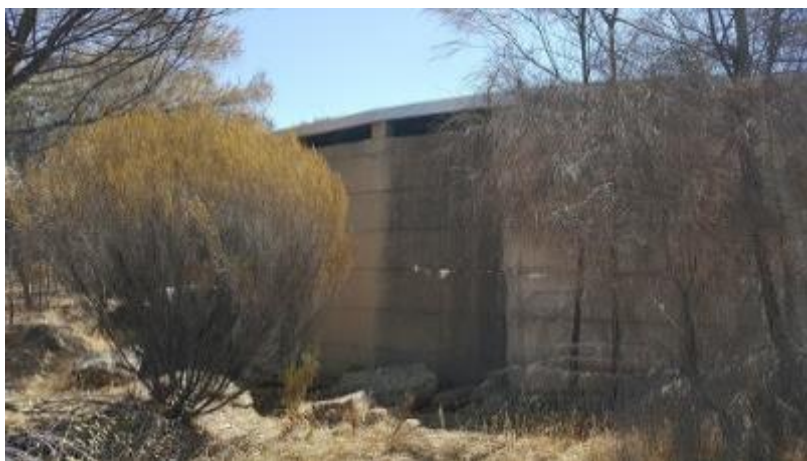
Pallarup Tanks and Standpipe

Off Rock catchment

1200KL tank maximum capacity – available at standpipe located off Lake King Ravensthorpe road – standpipe is blue neat information board (signposted).

Current capacity unknown.

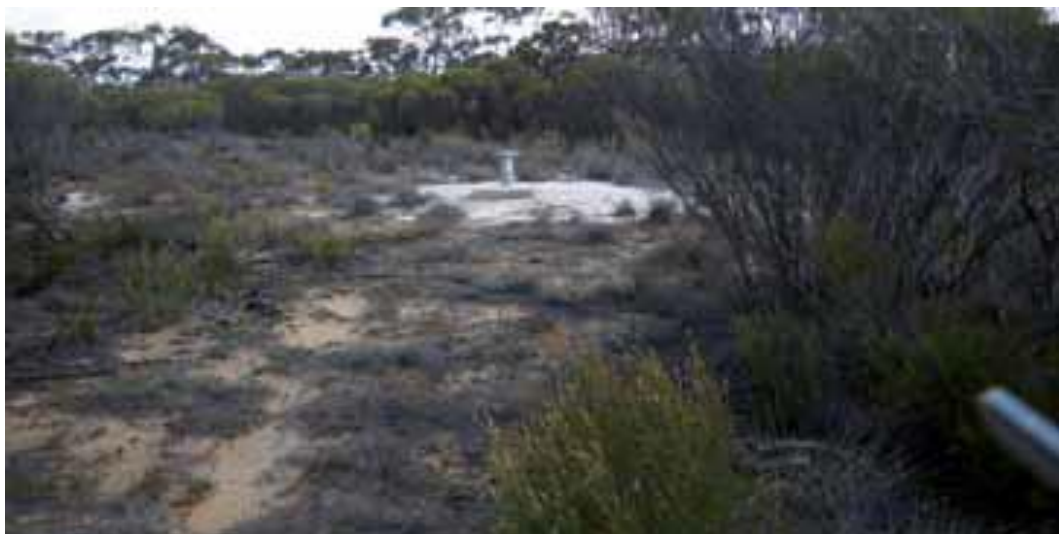
Mount Madden Bore

The Department of Water and Environmental Regulations has contracted a driller to equip a bore at Mount Madden in Lake Grace near the Mount Madden Dam. The Bore is call MM3 and is suitable for livestock (pictured below).

BORE DETAILS – 100 MM PN9 PVC CASING- BORE IS 28.3 METRES DEEP – STANDING WATER LEVEL 10.5.

The Bore is located on Muncaster Road in the Shire of Lake Grace and is available for farmers to access. The Bore is equipped with piping and pump. The flow rate is 1 Litre per second. Farmers will need to **take their own generators to operate** the bore. Details are below. Note MM6 bore is capped and not available as it is too salty (~1454mS/m).

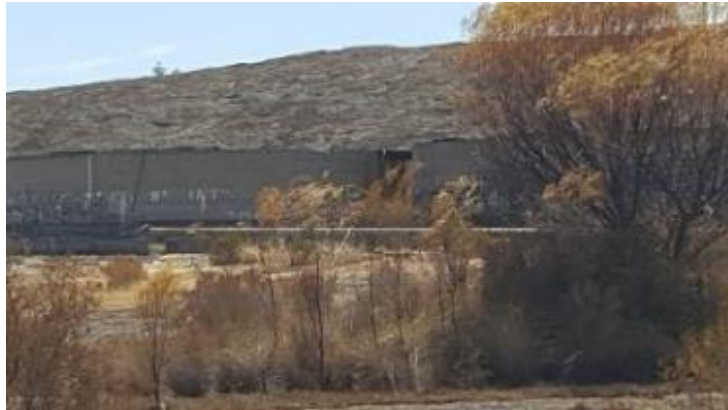
Purtna Rock –Tanks

Location – Purtna road

2270 KL capacity

Current capacity 30% 681 KL available

Standpipe facilities.

Note: Water Corporation will top up tanks as required (please contact Tracy Calvert if this is required)

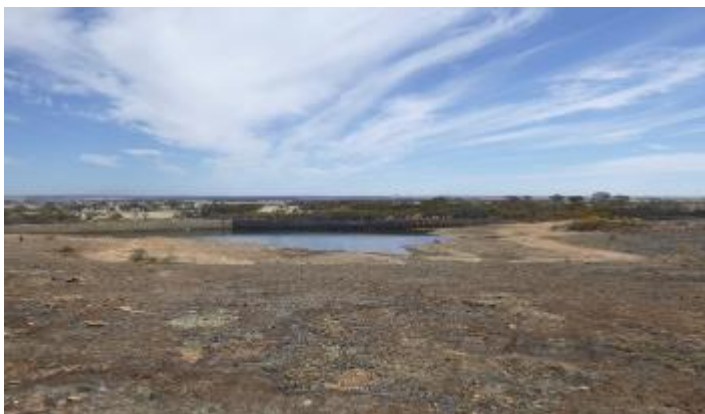
Dingo Rock

Location: North of Lake Grace town Duckworth Road

Maximum capacity 45,500 KL

Current capacity 10% 4550 KL available

16/04/2019 analysis of swipe card use since site visit (66.7KL accessed)~3000KL available.

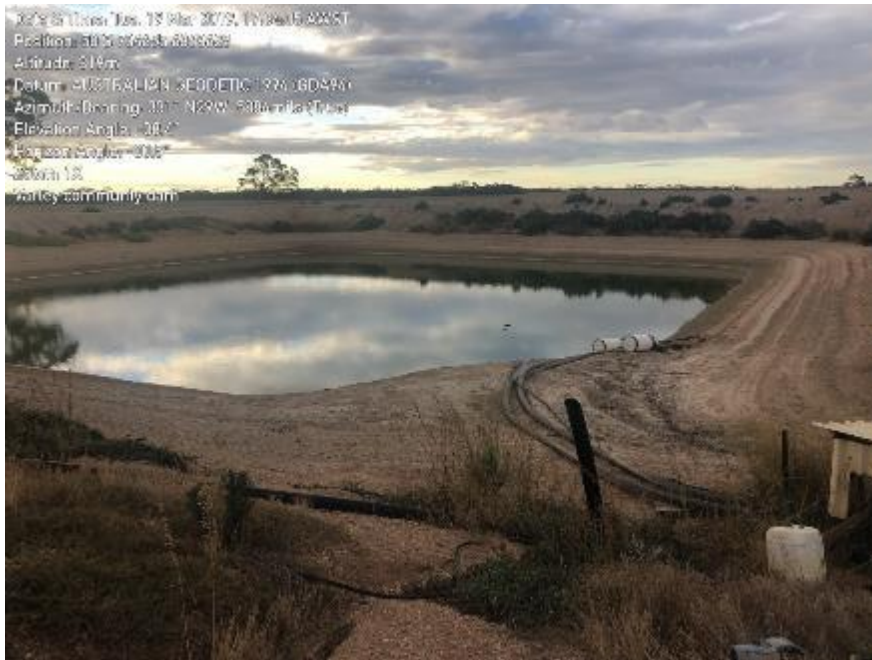
Varley Dam

Location – Hyden Lake King Road (Varley)

28,000 KL capacity

Current capacity <20% 6000 KL available – catchment CBH hardstand

Standpipe and tank facilities

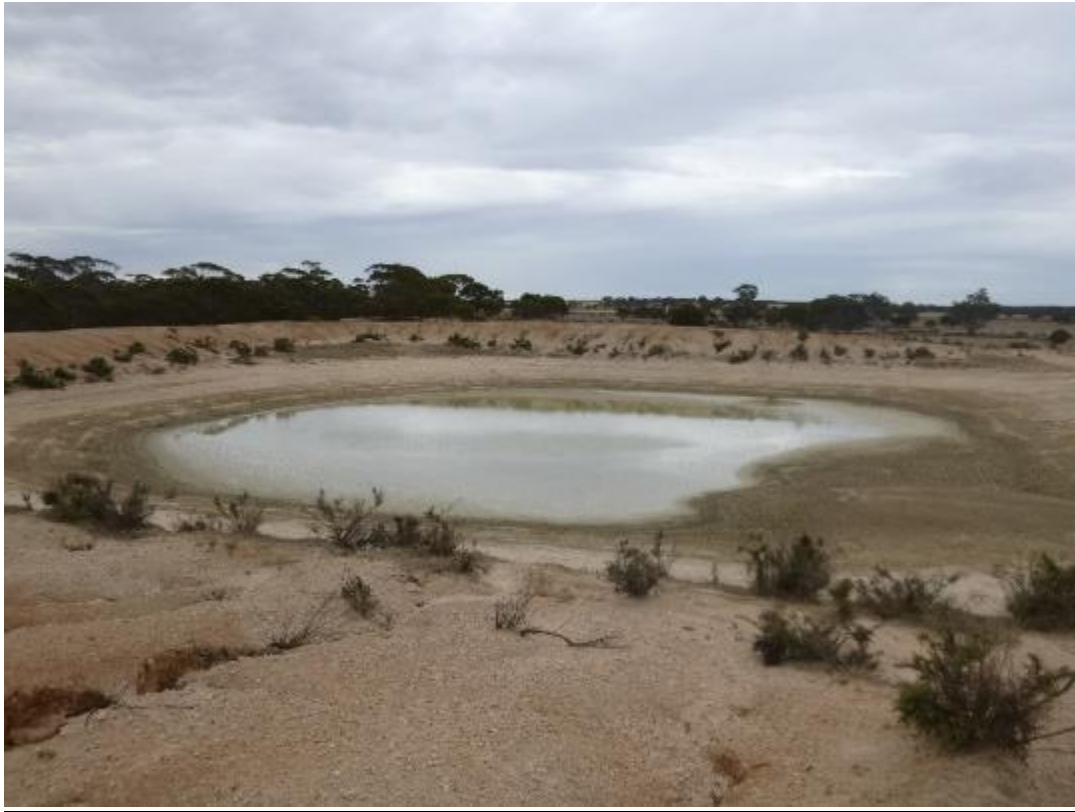
Lake Biddy Reserve 19649 Witham Road aa Dam

~15,00KL maximum capacity

Current capacity – to be assessed.

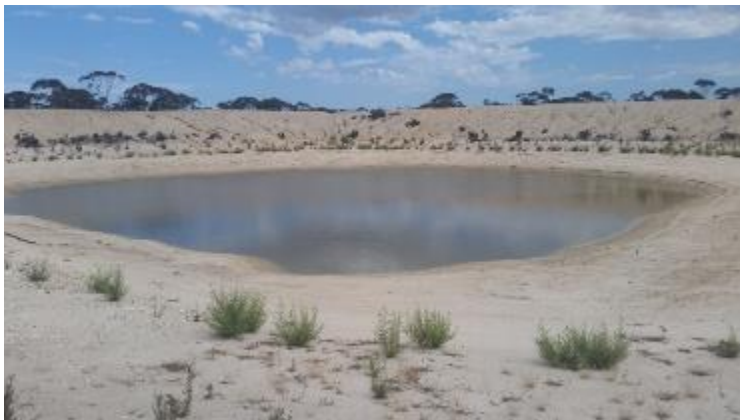
13 Mile Dam

105 Newdegate Road/14 Mile

~20,000 KL maximum capacity

Current capacity 25% 2500 KL available.

Contractor report April 9th – still adequate supply for livestock.
